Manhole Inspection Summary

Manhole # S270__014MH

Location Address: **1203 Cleveland st**

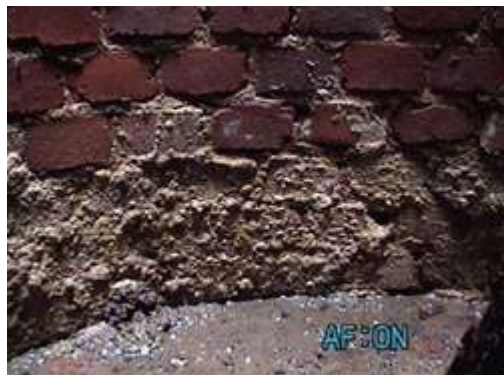
Defect 4

Infiltration: ☐ None ☐ Joint ☐ Cracks ☐ Mortar ☐ Roots ☒ **Wall**

possible infiltration in barrel unable to find leak

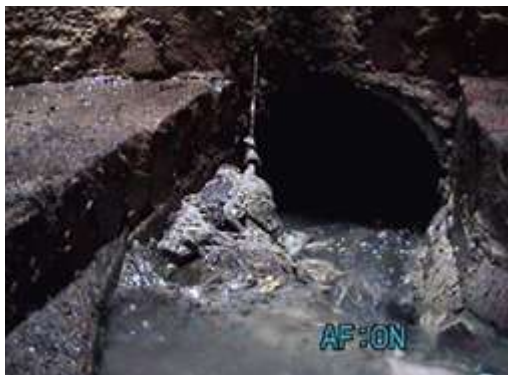
Defect 3

Condition: ☐ Sound ☐ Cracked ☐ Root Intrusion ☐ Deteriorated ☐ Leaks ☒ **Debris**

debri in channel

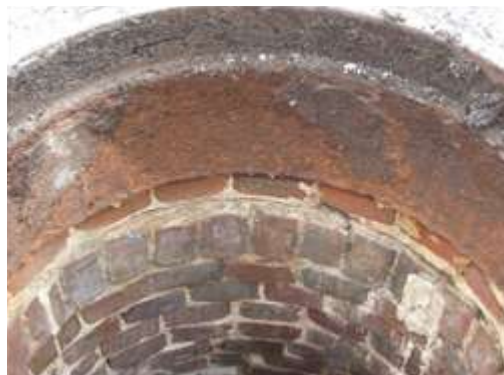
Defect 2

Frame Offset: **1.** (in.) Condition: ☐ Sound ☐ Cracked ☒ **Leaks**
25

Infiltration: ☐ None ☐ Joint ☐ Cracks ☐ Mortar ☐ Roots ☒ **Wall**

rusted frame/ signs of infiltration at chimney

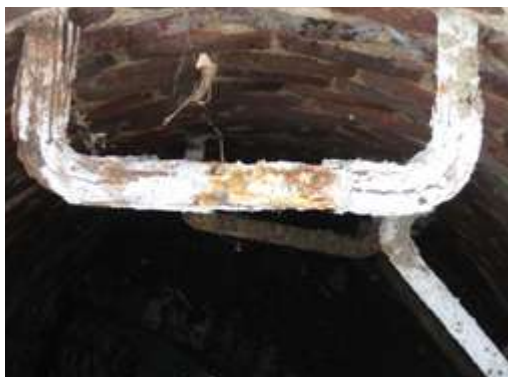
Defect 1

Steps Count: **8** Missing: **0** ☒ **Corroded**

rusted rungs

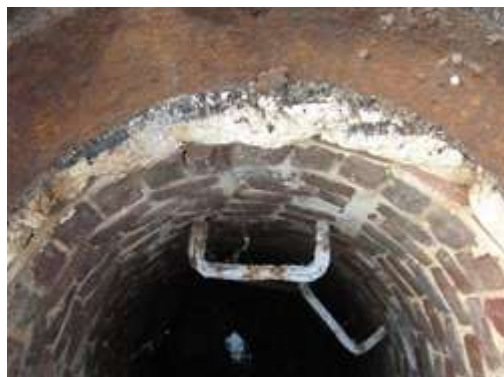
Defect

offset

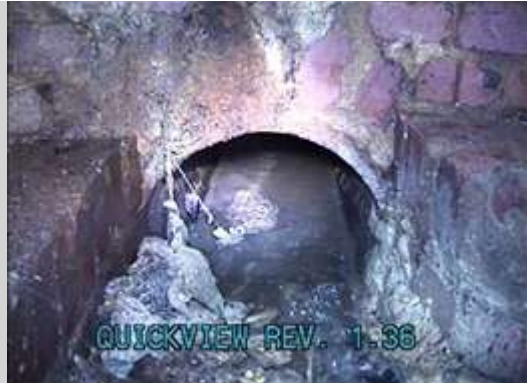
12 O'Clock Outflow

Pipe Height: **13.2** (in.) Rod and Bar (Angled)
Pipe Material: **Clay** ☐ Pipe Lined
Invert Depth: **13.67** (ft.) Flow Characteristics: **Slow**
Deposits: ☐ None ☐ Mud ☒ **Sludge** ☒ **Debris** ☐ Grease
Silt Depth: **4** (in.) Deposits Extent: **Heavy**
Infiltration: **None** Pipe Seal Cond: **Sound**

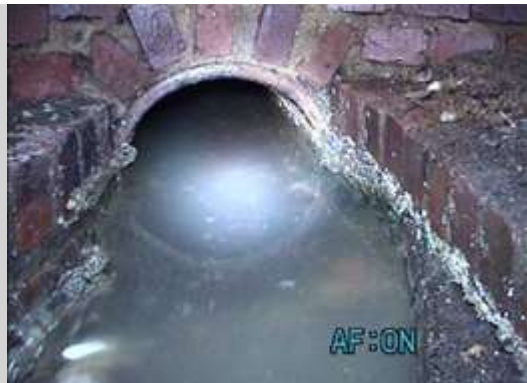
3 O'Clock Inflow

Pipe Height: **12** (in.) Rod and Bar (Angled)
Pipe Material: **Clay** ☐ Pipe Lined
Invert Depth: **13.44** (ft.) Flow Characteristics: **Slow**
Deposits: ☐ None ☐ Mud ☒ **Sludge** ☒ **Debris** ☐ Grease
Silt Depth: **3** (in.) Deposits Extent: **Medium**
Infiltration: **None** Pipe Seal Cond: **Sound**
